THE STATION

NFPA Case Study: Nightclub Fires

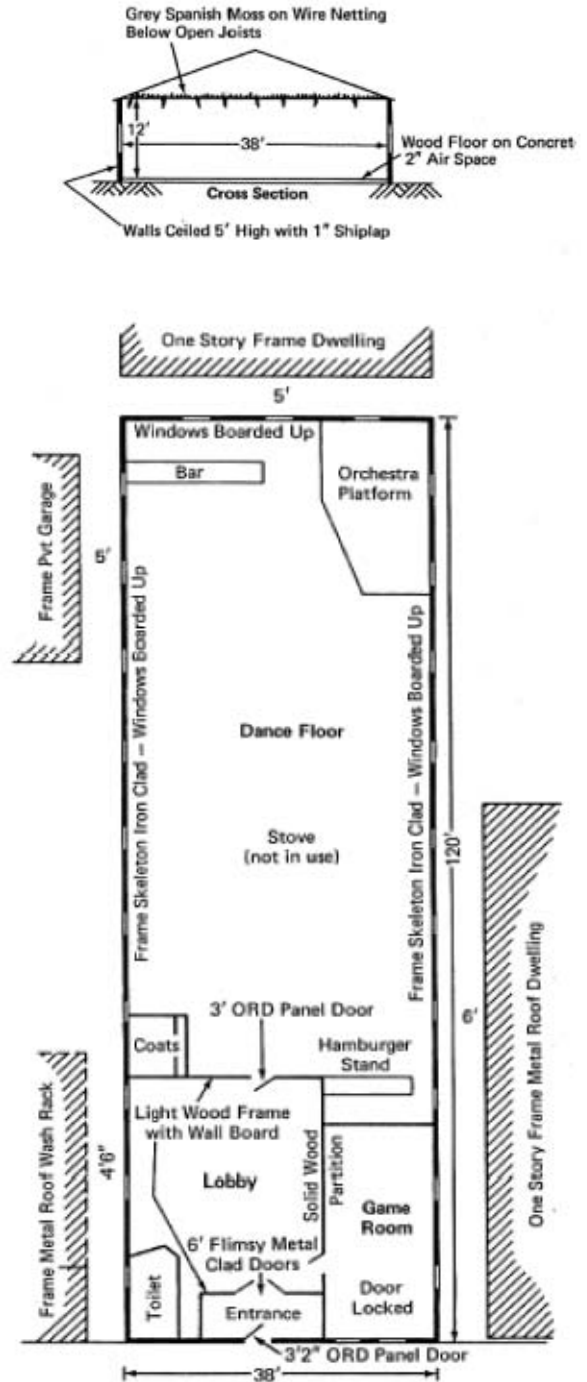
FIGURE 1 Layout of Rhythm Club (NFPA)

At approximately 11:15 p.m., a fire started near the hamburger stand, which was located adjacent to the only exit from the building. The fire quickly involved the Spanish moss, spreading the fire rapidly throughout the building, and above the crowd.

Patrons in the vicinity of the entrance were able to escape. However, those beyond the lobby area were quickly trapped by the fire, as pieces of the burning moss began to drop onto the fleeing occupants, igniting their clothing. The fire forced those who remained inside deeper into the building toward the orchestra platform.

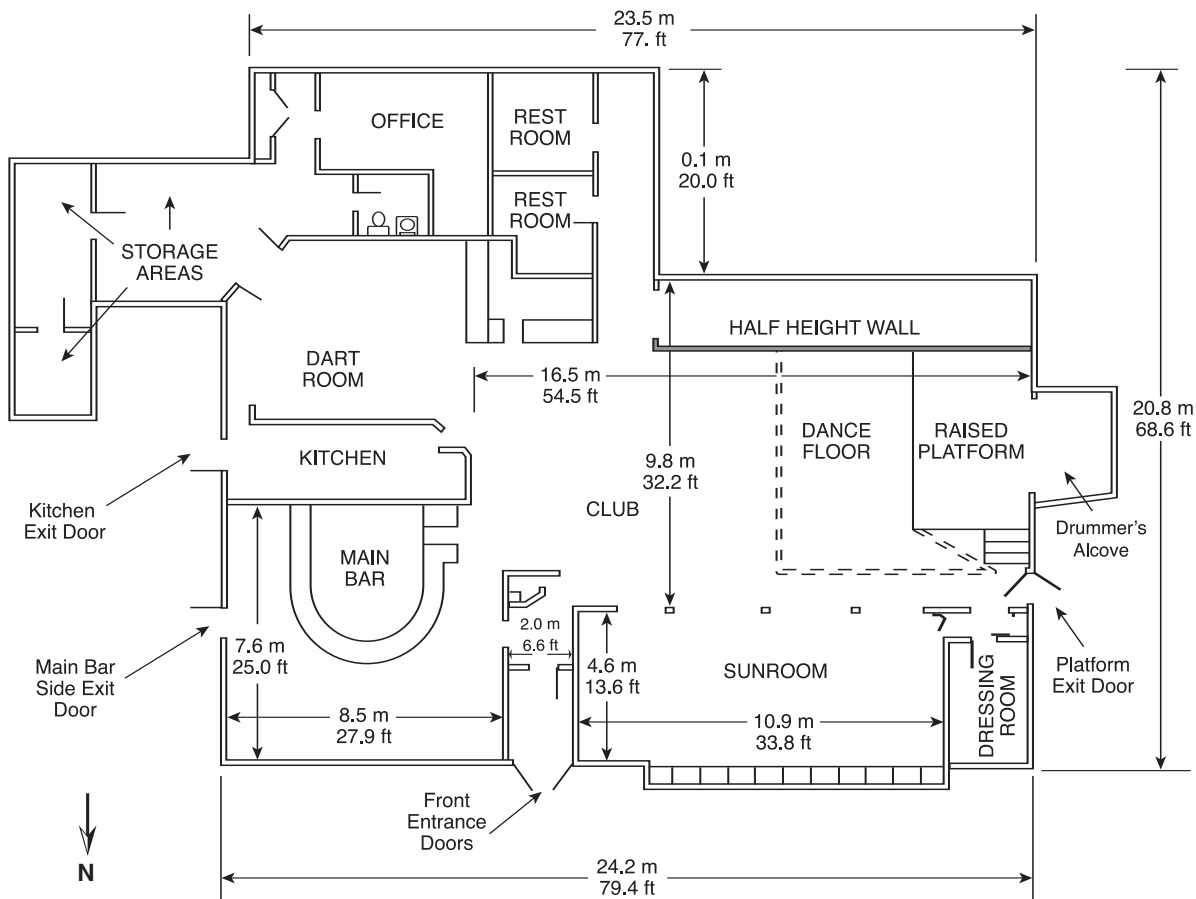
FIGURE 6 The Station Building Floor Plan.

The interior of the building was arranged into two distinct areas: the bar and the club. The bar area was located in the northeastern portion of the building (to the left as one entered the front entrance). This area also included the kitchen and dart room portion of the facility. The club portion, which encompassed the majority of the facility, was located west (right) of the front entrance. This area of the facility included the dance floor, the platform, and the sunroom, which contained billiard tables. (See Figure 6.)

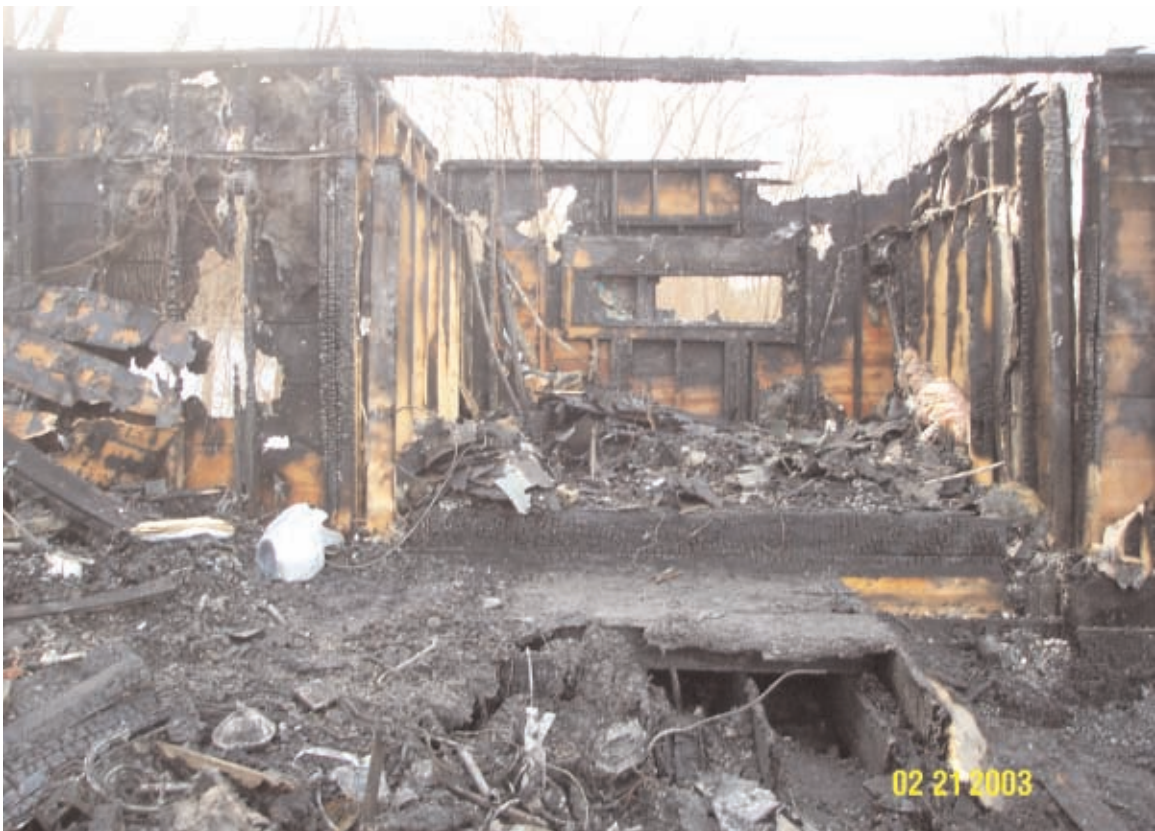
When comparing The Station incident with the other historic fires in assembly occupancies, one of the common factors among them is the presence of combustible interior finish, contents, and furnishings. The presence of combustible interior contents can be linked to the fire spread in the Rhythm Club (dried Spanish moss hung from the ceiling rafters), the Cocoanut Grove (furnishings and decorations), and the Beverly Hills Supper Club (wall and floor coverings). In The Station fire, expanded foam insulating materials were reportedly in place on

FIGURE 7 View from Interior of Club Showing the Platform and Drummer's Alcove (NFPA).

the walls adjacent to the platform and in the drummer’s alcove space.

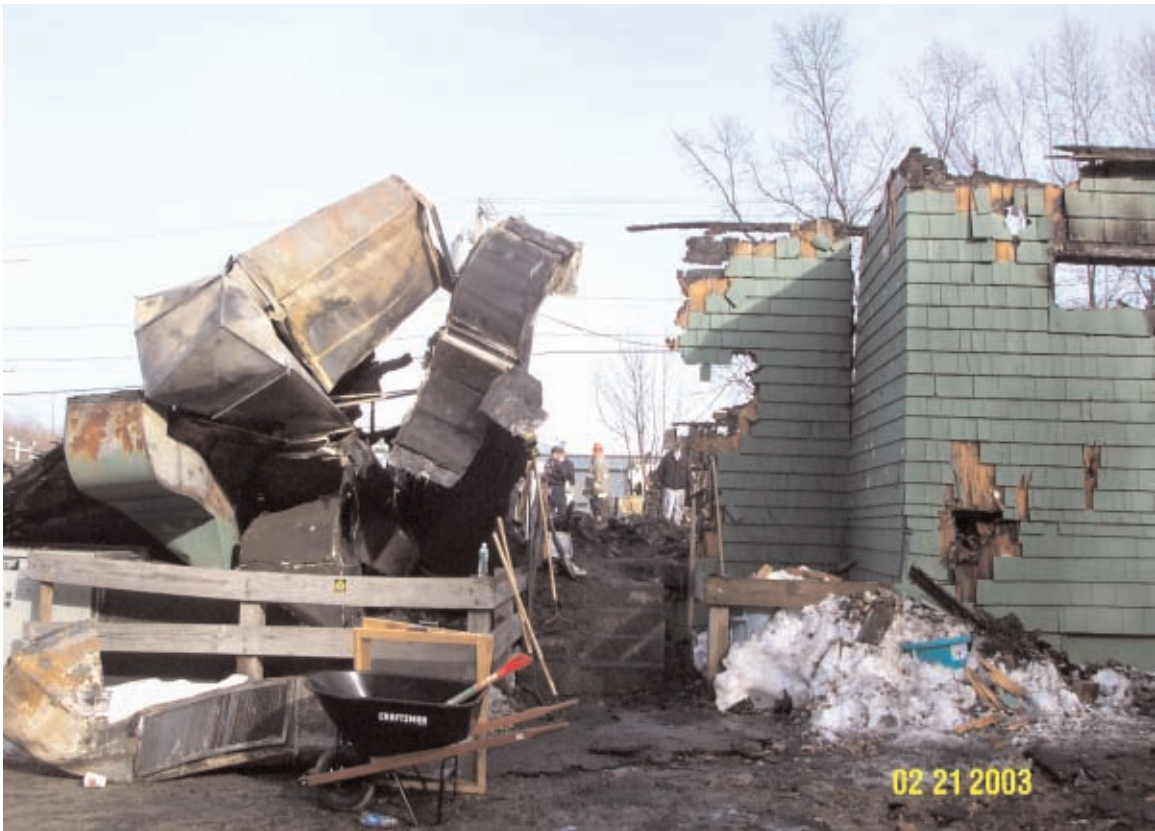
FIGURE 8 Exterior View of Exit Adjacent to Platform Area (NFPA).

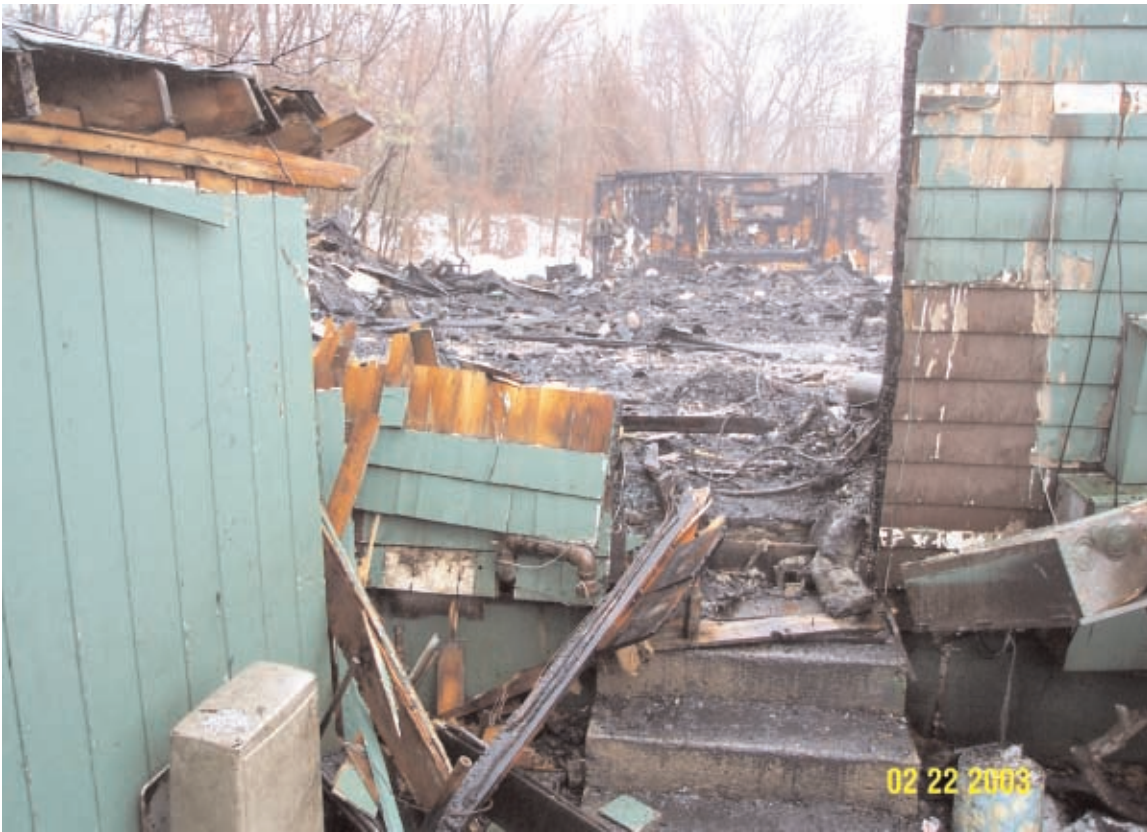
FIGURE 9 Exterior View Showing the Kitchen Exit Looking Toward the Platform Area (NFPA).

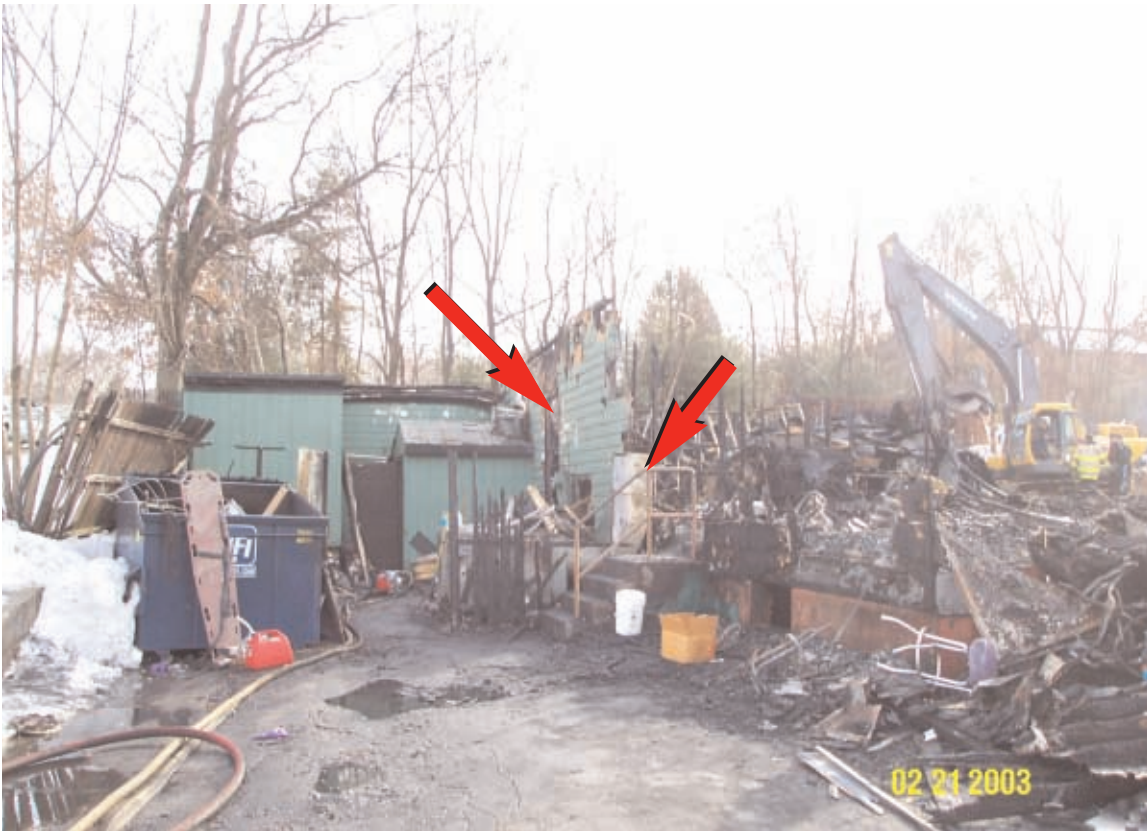
FIGURE 10 Exterior View Showing Both the Bar and the Kitchen Exits (see arrows) (NFPA).

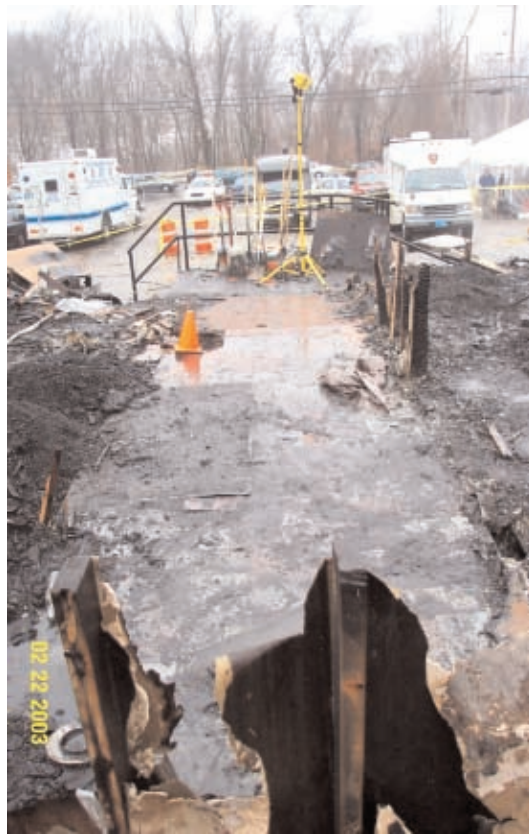
The entrance to the facility was arranged with a short corridor, approximately 15 ft (4.6 m) in length and 6 ft 6 in. (2 m) in width. At the end of this corridor there were doorways to the right and left. The bar area was located to the left, while the club area occupied the space to the right of this corridor.

FIGURE 11 Interior View of Front Entrance Corridor Facing North Through the Main Entrance (NFPA).
