## Mean Means of Egress

By Mark J. Berger

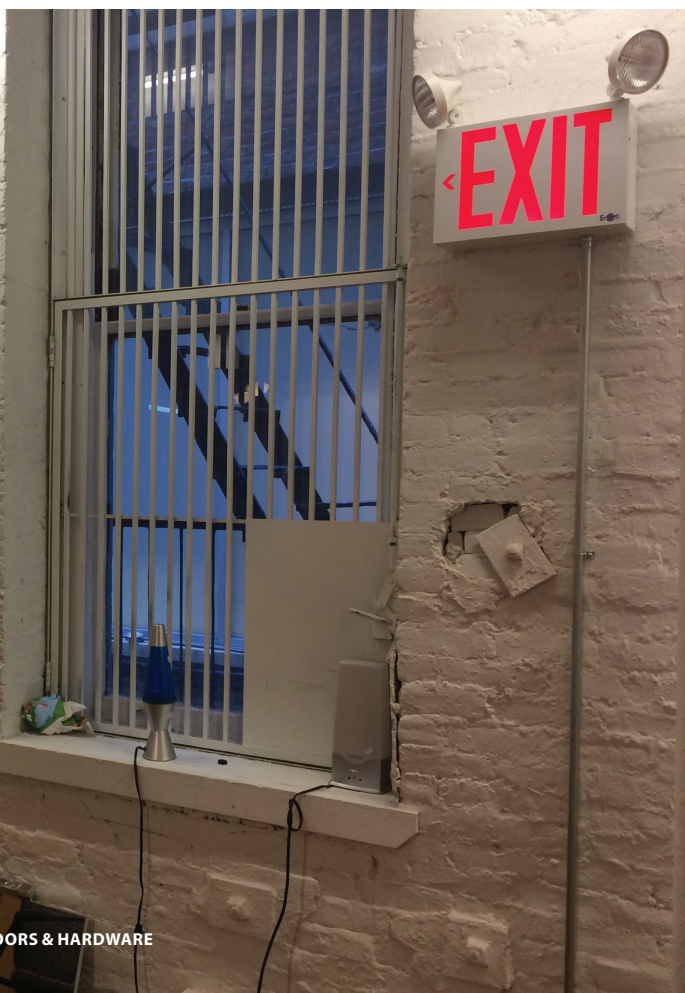
### DRESSING ROOM EXIT

Fire escapes are accessed by windows in the older buildings, and as a result, the windows are a security hazard. NYC has stringent codes for approved gates to be used on these windows, but they are specifically designed for residential applications, as per the multiple dwelling code. They are not permitted as a means of egress in a retail establishment.

At first I followed the exit sign, and it led me to a dressing room door. I waited patiently for the patron to leave the dressing stall, and when the door opened, I could clearly see that there was no secondary means of egress in the stall.

So I looked at the exit again and realized that the window grills were intended to be the exit—except that's not legal for retail establishments. And this was the first floor—no balcony. Clearly an exit door should replace a window.

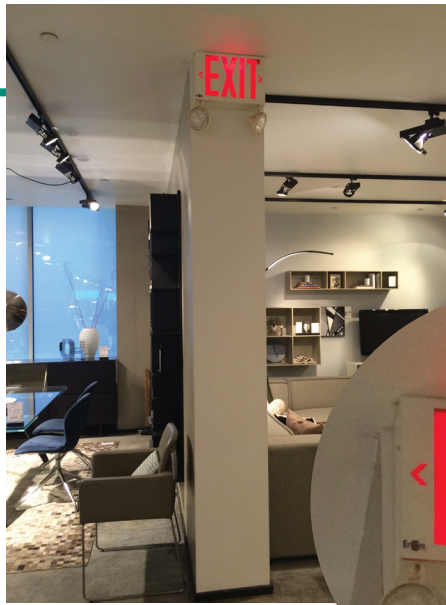
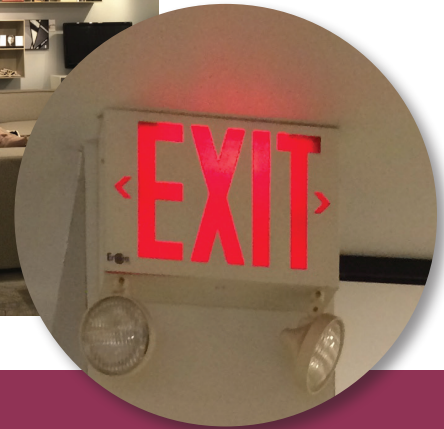
### LEFT OR RIGHT

Many retail establishments are combined storefronts. Here the exit sign is mounted on what would have been the dividing wall between two separate stores. They have been combined for this furniture retailer.

I followed the sign in both directions. To the right was a completely sealed room (you can see the solid wall in the background). Absolutely no exit. A storefront window was visible on the left, so I had hopes of finding at least one exit. There was even a sign above the exit door, but it was unlit. See the next set of photos.

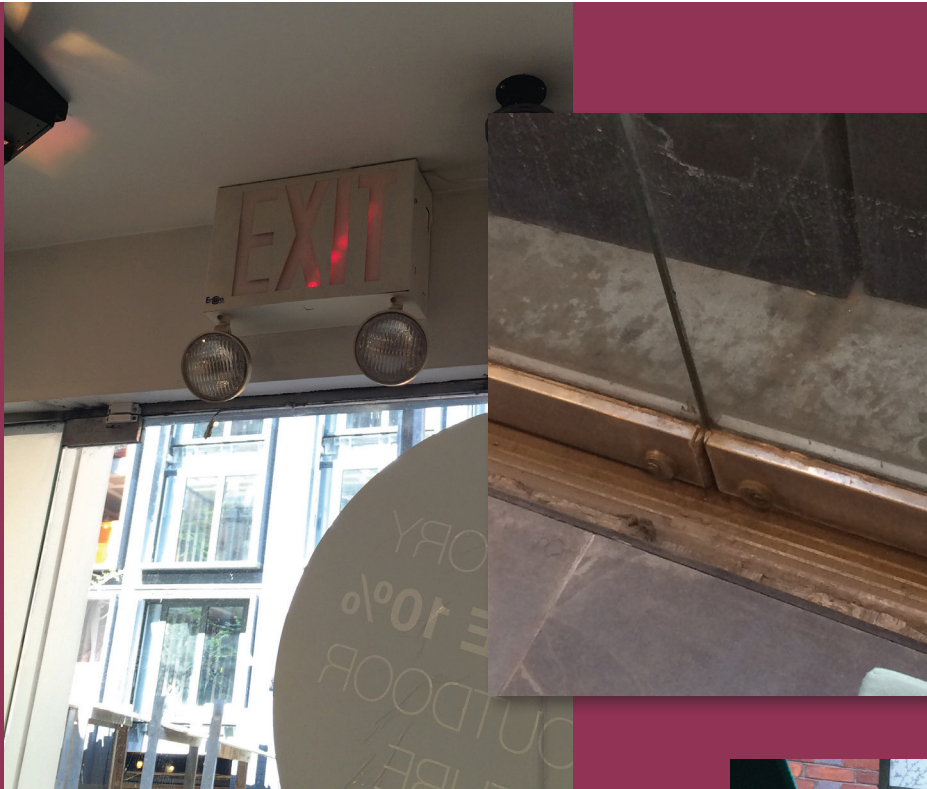
### UNLIT EXIT SIGN

There was indeed a pair of doors under this exit sign, but the sign appears to have been painted over, and very little of the red sign lighting is visible. There aren't any exit devices on the door, and both doors are sealed by the deadbolt in the bottom rail. Had you been able to open the door, you would have hit the black planters.

So no exit, left or right.

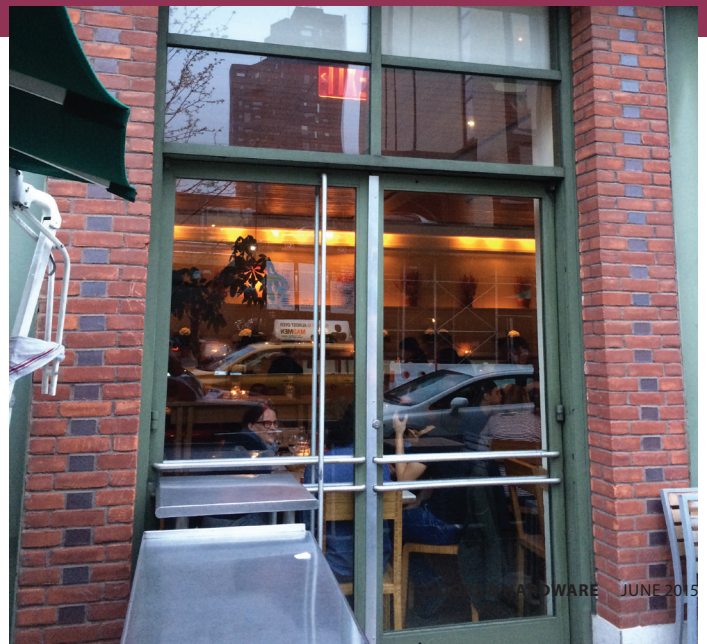
### TABLES IN AND OUT

Winter refused to depart New York before the end of April this year, so many restaurants that had hoped to have outdoor seating were out of luck. Also out of luck were the diners in this restaurant, as the exit door was blocked by an unused table. But they wouldn't have been able to get to the door without knocking over the people seated at the table on the inside that was also blocking the door.

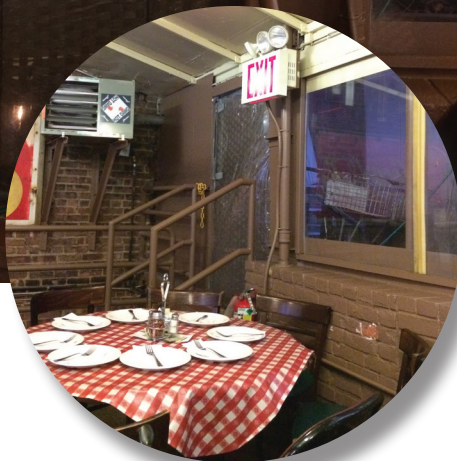
### BABY, ITS COLD OUTSIDE

This table and exit door are in one of New York City's oldest pizzerias. It claims to be the first, but so do about three or four others. The restaurant has expanded nicely and has taken over space in several adjoining buildings while retaining the original entrance and location. This section is on the second floor and is actually above the kitchen and pizza ovens.

This was a particularly cold winter with strong winds. I guess the door was not quite up to the task of keeping out the draft, so in order to provide comfort to the diners, the restaurant decided to provide a layer of weather-proofing with a full-size plastic sheet taped in place. You can even see the wind stretching it.

Had you gotten past this obstruction, it would not have done you much good. Note the bicycle that is visible through the window. The back of the bicycle has to be blocking the door.

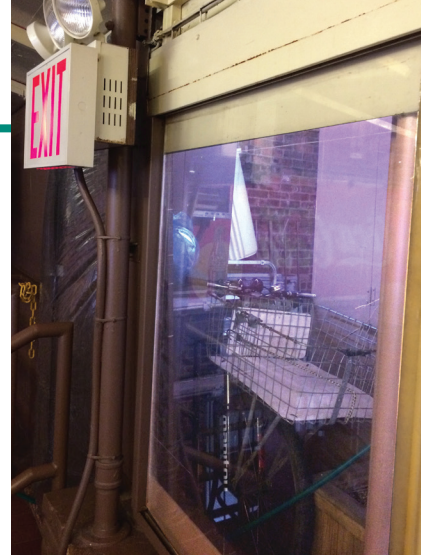
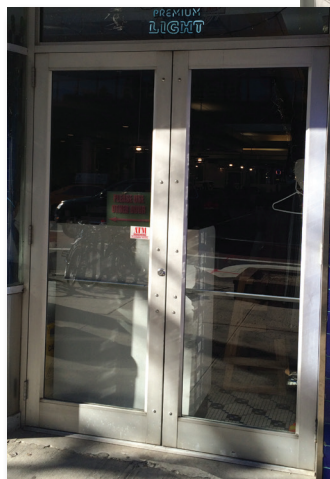
### BUS STATION

Prior to entering the restaurant, I could see that there was going to be trouble. Having been a bus boy, I know what a bus station looks like from the front or, in this instance, visible through the glass doors, from the rear. Sure enough, upon entering the restaurant, the offending blockage was easy to see. The exit sign was clear and lit above the door, and if you look to the right of the bus station, you can see a little of the exit device.
