THE STATION

NFPA Case Study: Nightclub Fires

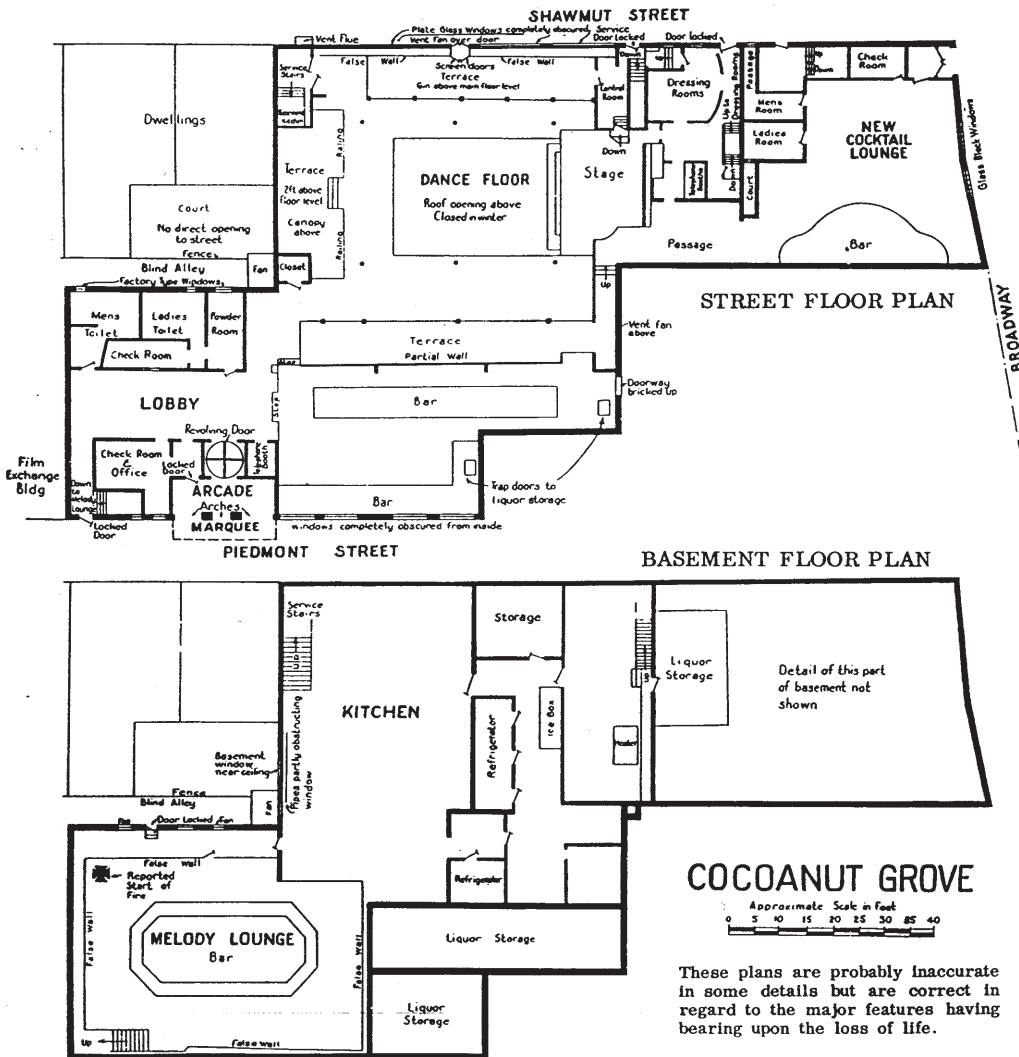
FIGURE 2 Layout of the Cocoanut Grove (NFPA)

All other doors within the building that would have provided access to the outside were locked or obscured at the time of the fire. One of these locked doors was located on the Piedmont Street side, to the left of the marquee over the main entrance. Had this door been unlocked at the time of the fire, it would have provided a means of egress for the patrons in the Melody Lounge, without them having to travel into the lobby and use the revolving door. (See Figure 2.)

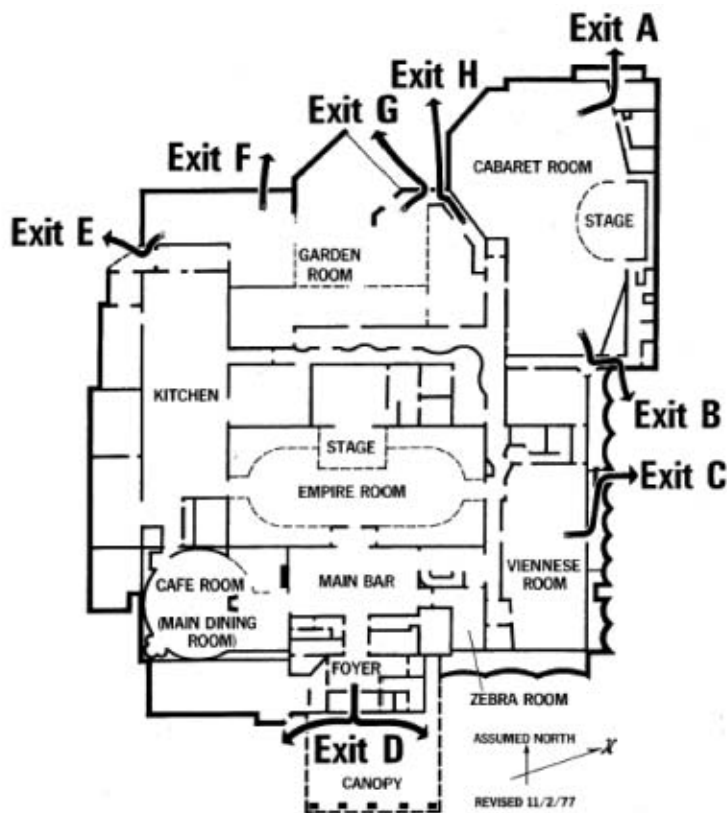
FIGURE 4 Exit Locations in the Beverly Hills Supper Club (NFPA).

There were eight exit discharge points from the complex. (See Figure 4.) However, one located in the Viennese Room (C), was “disguised” as a window, even though there was an exit sign installed above the door. Another door adjacent to the Cabaret Room was reportedly locked at the time of the fire (H). This door was adjacent to another exit, equipped with a double door (G).
