The Effect of Oversized Clearances on Fire Door Tests

By Lori Greene, AHC/CDC, FDAI, FDHI, CCPR

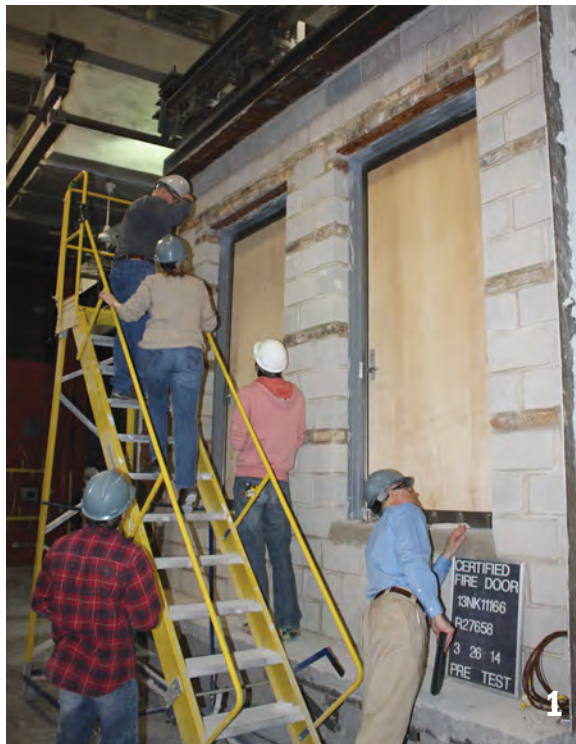
1. The installed Category A and Category B wood doors are examined by Chuck, Courtney and Uriah Noble, Michael Nicasio of UL, and Dan Hibbs of Eggers Industries.
2. Uriah Noble installs the Fire Door Extender to bring the 2-inch bottom clearance into compliance.
3. The Crown Latch Protector installed behind the strike is used as part of the system to ensure sufficient latch engagement.

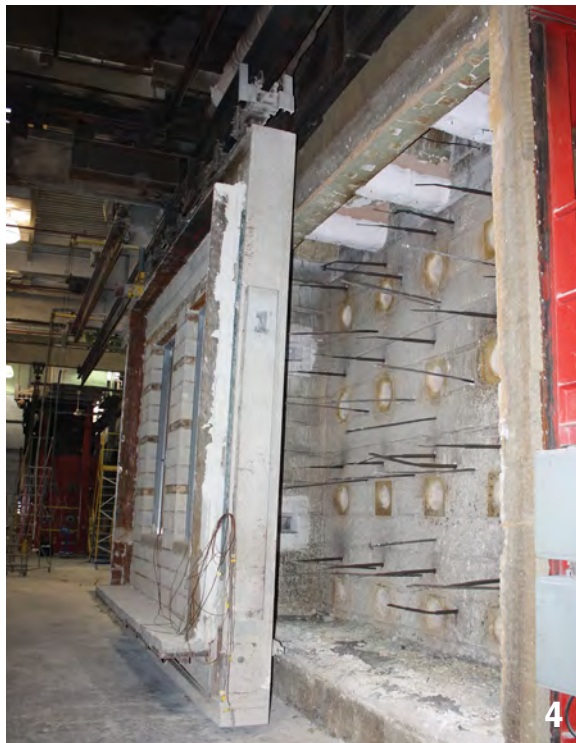
4. The masonry wall with two fire door assemblies ready for testing is moved into position adjacent to the furnace.

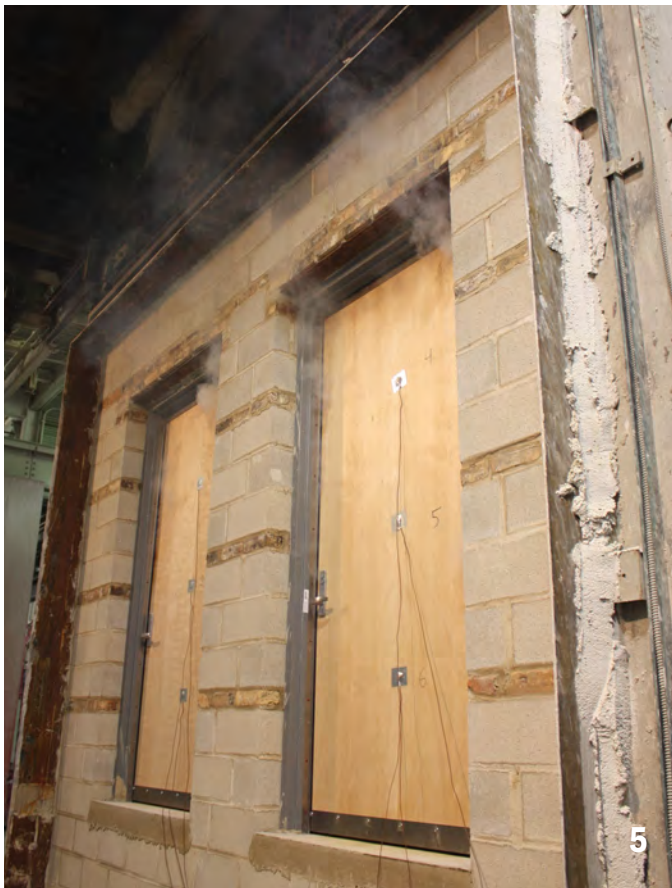
5. Testing begins. Three thermocouples remain attached to the face of each door for the first 30 minutes of the fire test.

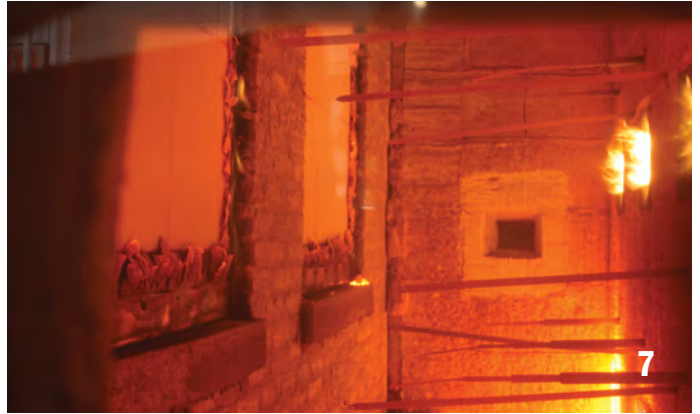
7. Inside the furnace the doors can be seen on the left, with the remnants of the veneer visible around the edges of the exposed core.

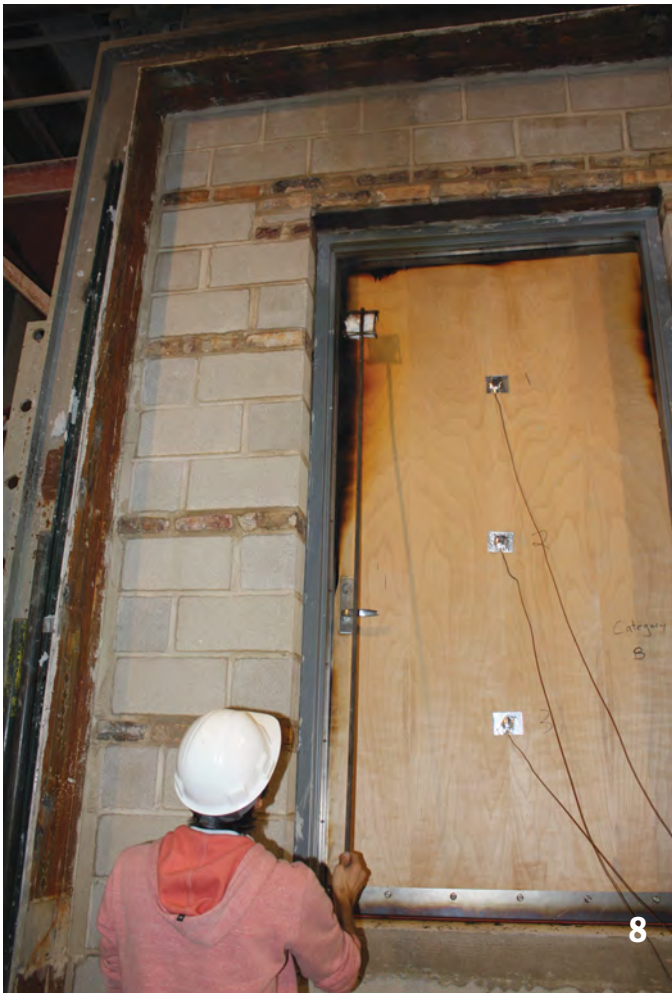
8. A cotton pad is used to ensure that there is not sufficient heat/flame transfer to ignite combustibles on the non-fire side of the fire door assembly.

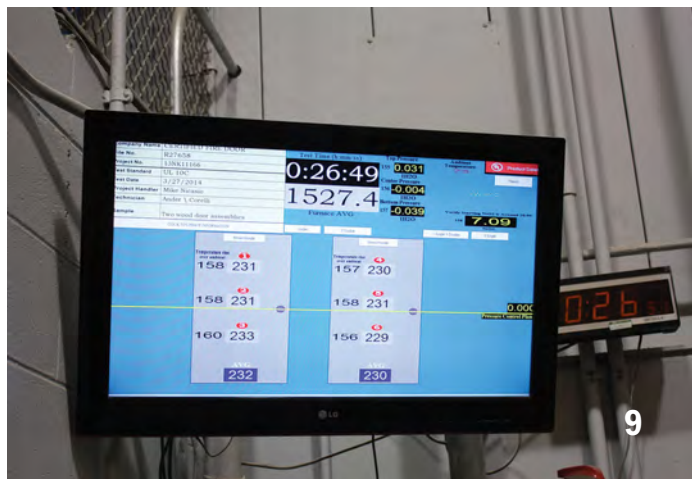
9. Monitors report the test progress. At 27 minutes into the test, the average furnace temperature was more than 1,500 degrees, but on the non-fire side we could stand directly in front of the doors—evidence of the protection fire doors provide.

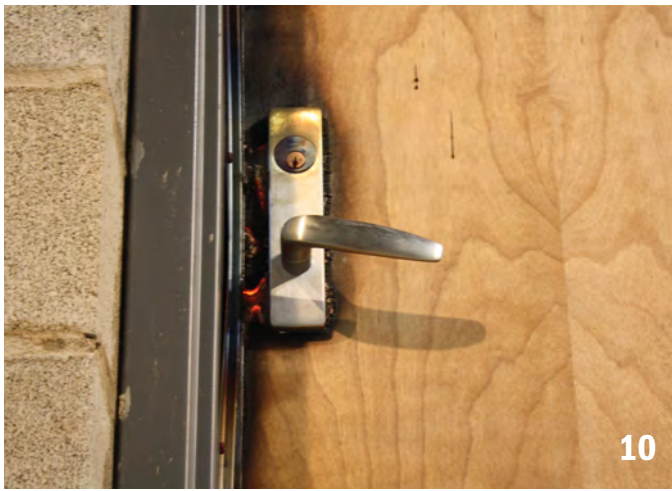
10. The Schlage L9000 series lockset remained latched throughout the test as required, although the furnace-side levers melted off as expected. Operable hardware is not required to be functional after the test.

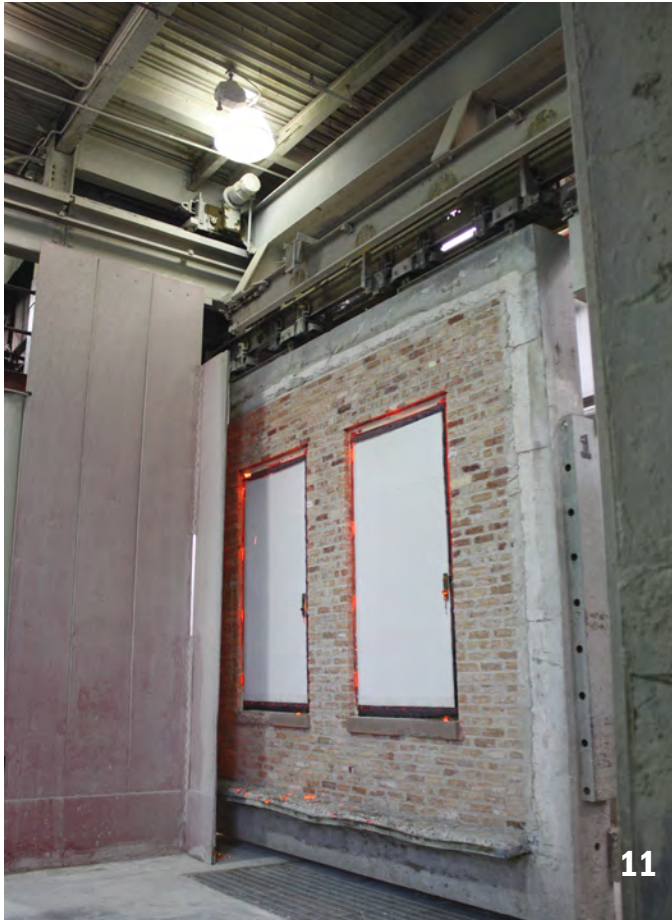
11. Upon completion of the 90-minute test, the doors are removed from the test furnace.
