# Terminated Stops and Door Bottom Seals

BY LORI GREENE, AHC/CDC, FDAI, FDHI, CCPR

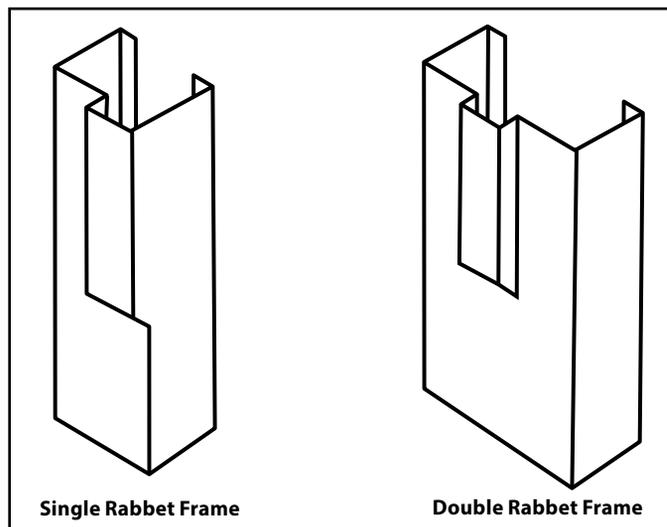
**M**ANY HOLLOW METAL FRAMES USED IN HEALTHCARE FACILITIES have terminated stops, also known as “hospital stops” or “sanitary stops.” A terminated stop is a modification to a door frame in which the stop is terminated above the floor, usually at 4 inches, 6 inches or 8 inches from the bottom of the frame. The bottom of the stop is closed at a 45-degree or 90-degree angle.

The purpose of a terminated stop is to make it easier to clean that area of the floor without the extra corners to catch debris or pathogens and to avoid getting cart or bed wheels caught on the stop.
